**HUDSON RIVER BASIN  
SANDGATE**

**LAKE MADELEINE  
VT 00007**

**PHASE I INSPECTION REPORT  
NATIONAL DAM INSPECTION PROGRAM**

**SEPTEMBER 1973**

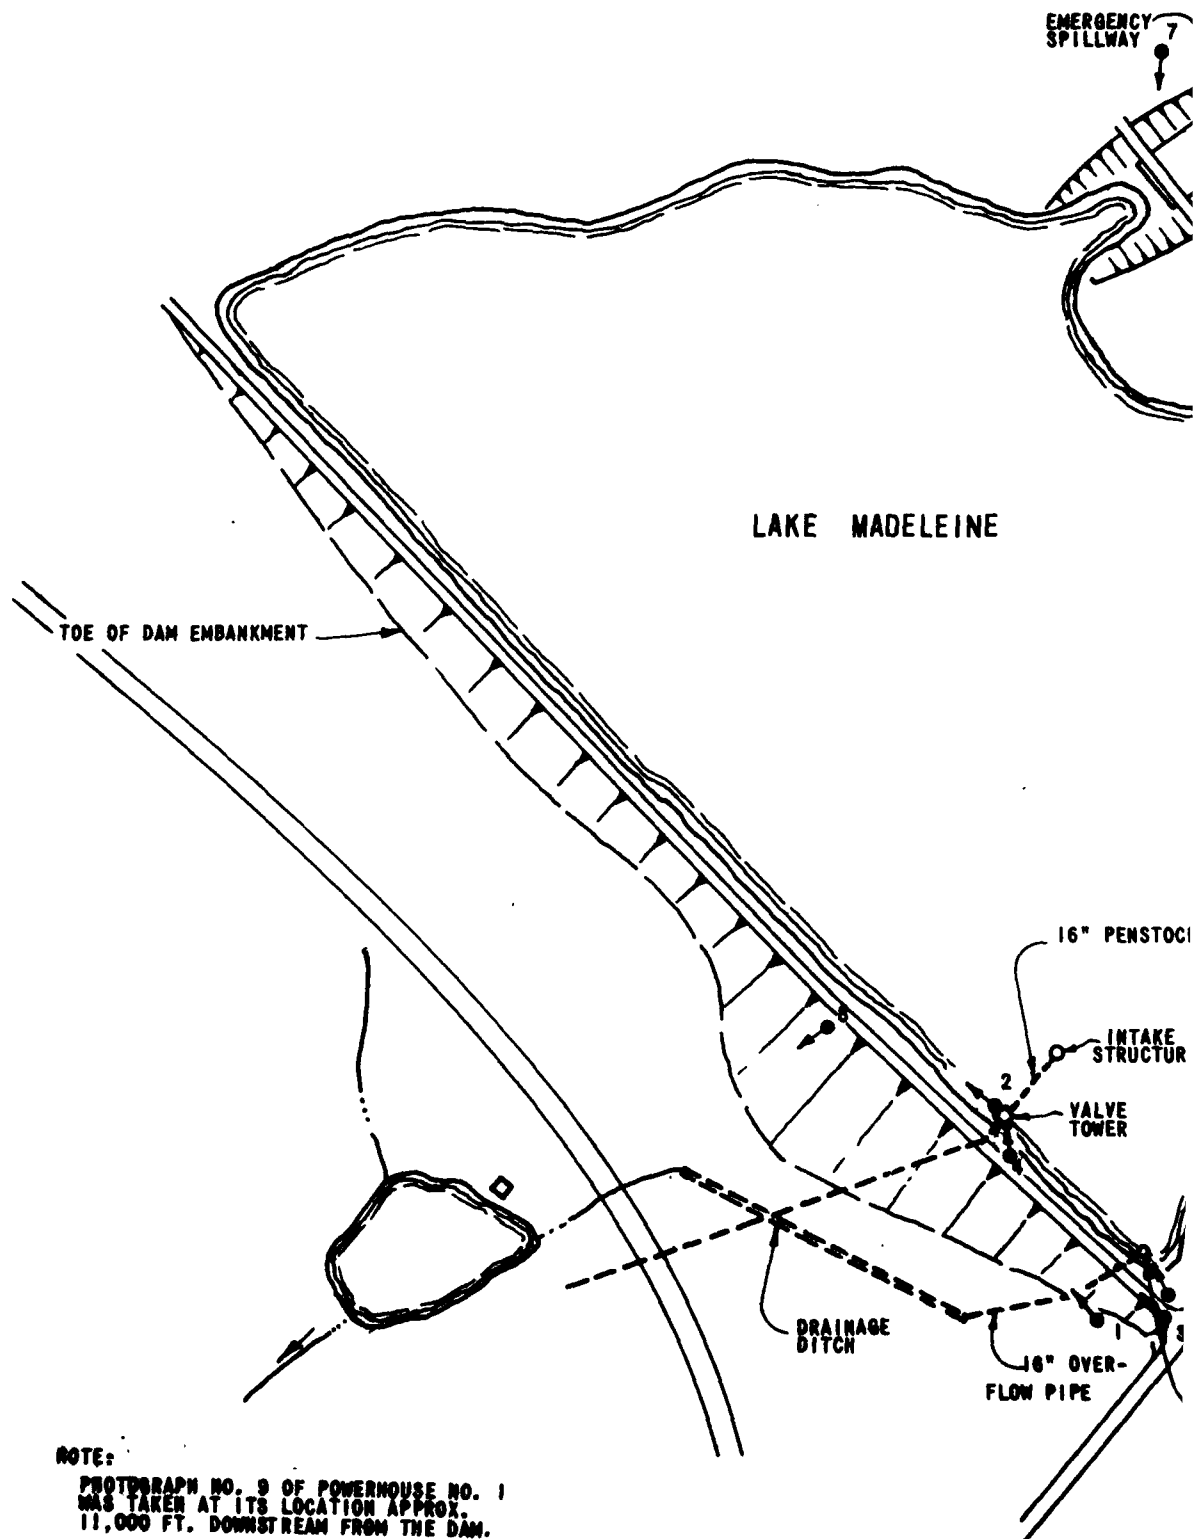
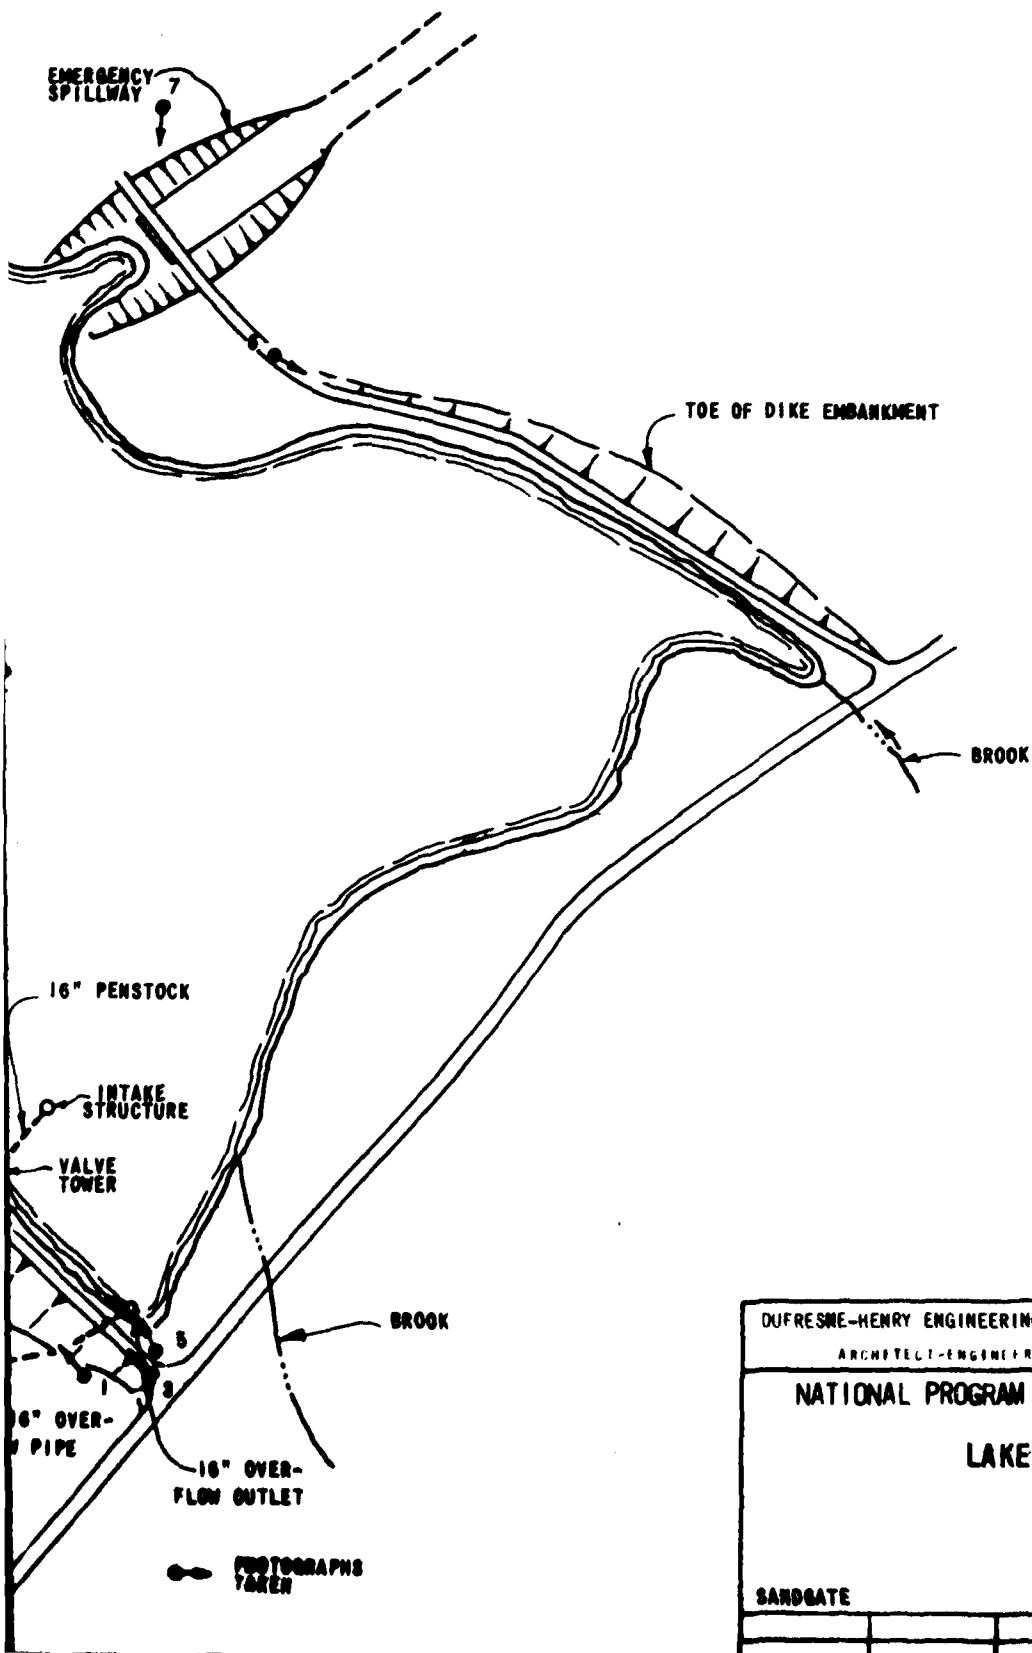
1. Downstream face of dam from left abutment.
2. Upstream face of dam toward right abutment from valve tower service bridge.
3. View of crest of dam from left abutment.
4. Valve tower and service bridge. Service bridge is out of alignment due to inadequate footing on the dam.
5. 16-inch diameter overflow pipe near left abutment.
6. View of dike at north end of impoundment from the left abutment.
7. Emergency spillway at north end of impoundment near left dike abutment.
8. Seepage collection pond and pumping station downstream of Lake Madeleine Dam.
9. Power House No. 1 located approximately 11,000 feet downstream of Lake Madeleine Dam.
